## Water / Nature: Pond creation for sustainable drainage

### Torphin Hill Golf Club

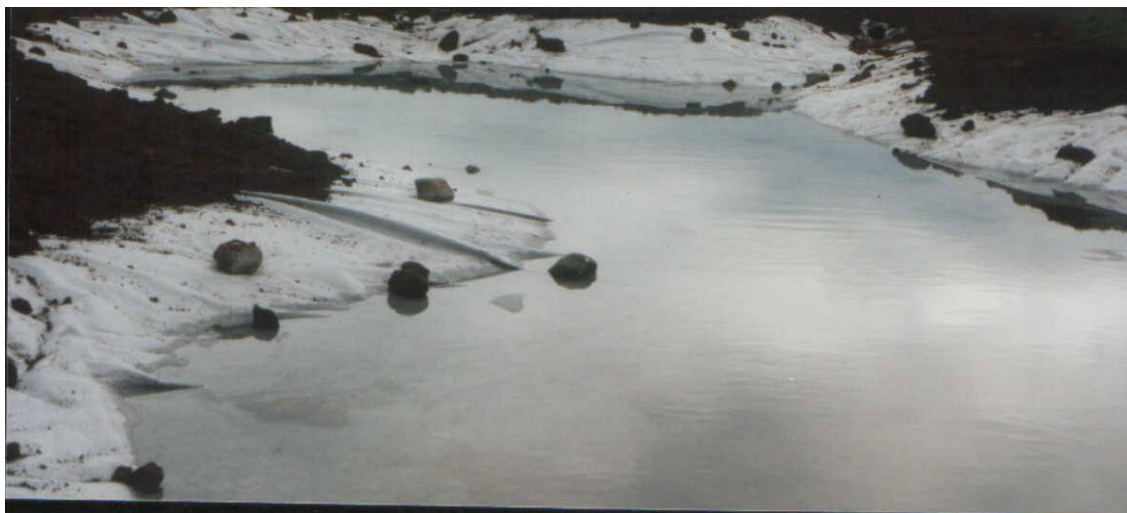
Of the wet areas one was in play and one out of play. The club's preference was to start with the one on the par three 17<sup>th</sup> where an elevated tee shot plays down over the managed burn. Although test pits and the greenkeeper's instincts were that the clay content of the soil would hold water naturally, it was decided that, despite the extra cost, the risk of a muddy hole in the middle of the fairway was sufficient to merit lining the pond, as shown in the image below.

Freshwater shrimps were present in the water supply suggesting good water quality. On the basis of this low pollution risk, it was decided to create an on-line pond. The burn was temporarily diverted through piping during pond construction. A shaped hollow was dug outwards from the burn-line to create varied depth and shallow sloping edges but of a size to enable a single piece of liner to be used, thereby avoiding joins and overlaps. The hollow was blinded with old carpet, recycled from members, to prevent stones piercing the liner. The butyl liner was rolled out and settled into place by team of enthusiastic volunteers. An outlet pipe was positioned to maintain and control the water level, round which the trimmed liner was strapped with huge amounts of waterproof adhesive tape. Rumbling stones were positioned to introduce aeration before entry to the pond. An earth bridge created a small holding pool before the inlet, to encourage the pre-settlement of any silt and control inflow rates into the pond. The liner was then covered with soil to the planned water level and the burn water redirected from the temporary piping to the pond, which filled up in less than 24 hours. Marginal planting and wildflower sowing was carried out along 50% of the pond edge, on the burn side, with the 50% on the fairway side mown to the edge for golfing reasons. The cost of constructing the Upper Pond was £5,000, of which 100% was acquired through grants via the Edinburgh Green Belt Trust (now called Edinburgh & Lothian's Greenspace Trust [www.elgt.org.uk](http://www.elgt.org.uk) )

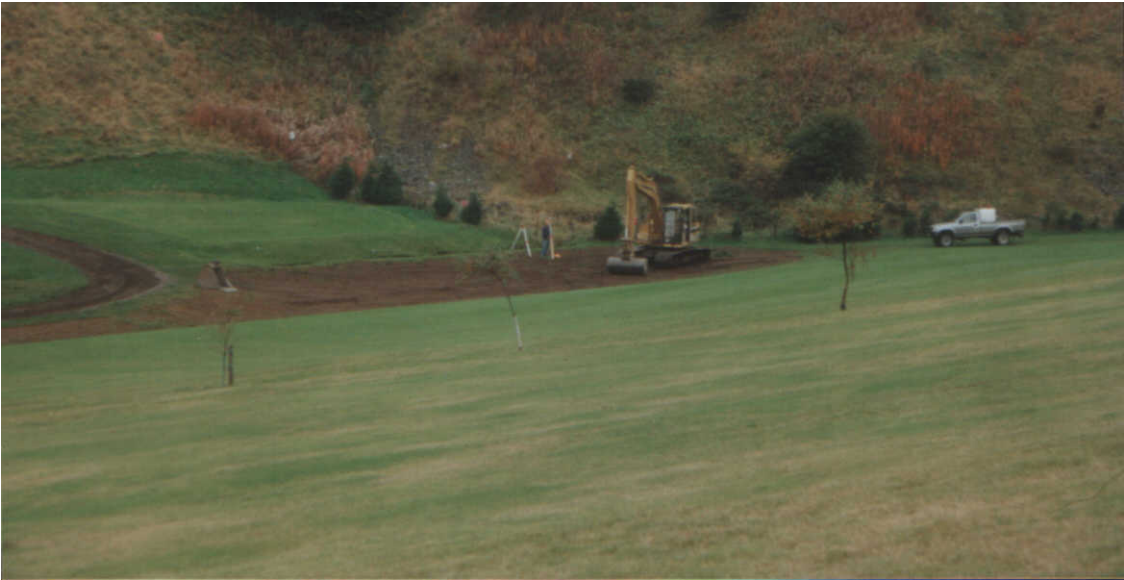
*Pond during construction*

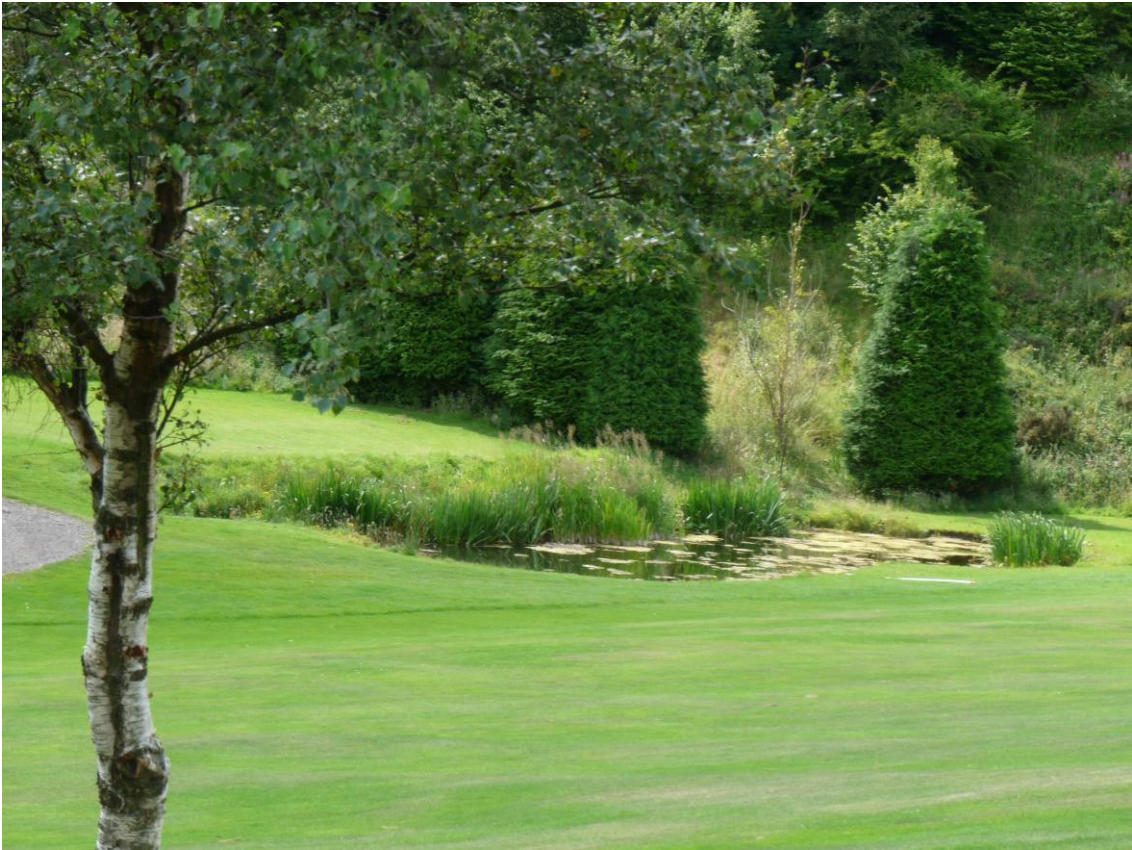
*Pond as it is in 2010.*

**The in play pond**, although by no means a failure, this more expensive pond has been much more problematic. Inflow and/or fluctuating water tables caused the liner to "hippo" up early on, requiring repeat weighting down. The pipe outlet has also proved to have too small a bore, as following heavy rain, the pond overfills, flooding the surrounding playing area. Plant establishment has been both restricted by golf and the liner, although unfortunately Canadian pondweed has established and now severely dominates the pond. Ironically, this has provided good habitat for newts, making the issue of its control highly sensitive. Another recurring problem has been that despite a well oxygenated water supply, shallow water rapidly heating up over the black liner during summer, causing heavy algal growth most years. Experiments have shown that when barley straw is aerated and placed inside sausage-shaped nets that float in the water, a natural chemical is released which controls the algae but does not harm other life forms in the pond. Such problems highlight the need to consider forward planning in terms of a 5 year habitat management plan for new ponds. This allows the club to budget and plan for any unforeseen problems.
